December 9, 2020  
File No. 20-122

**Re: Geotechnical Engineering Feasibility Report Review  
Dungeness Off-Line Storage Facility  
River Road, Clallam County, Washington**

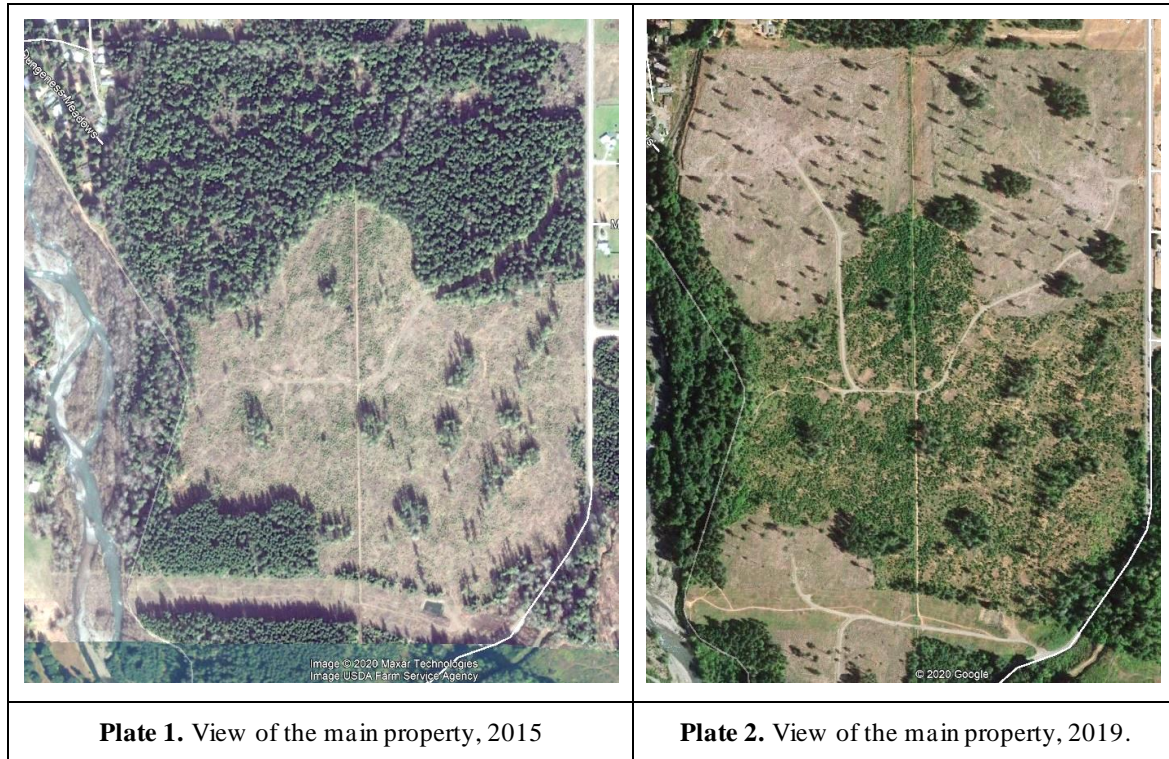
property as vegetated with grasses, shrubs and evergreen trees ranging from saplings to mature trees, which is consistent with the aerial image in Plate 1. Since then, the previously unlogged portion of the site, mainly in the north, northern portion of the site was logged (see Plate 2) and saplings have grown to heights of 10 to 20 feet in the southern portion of the site.

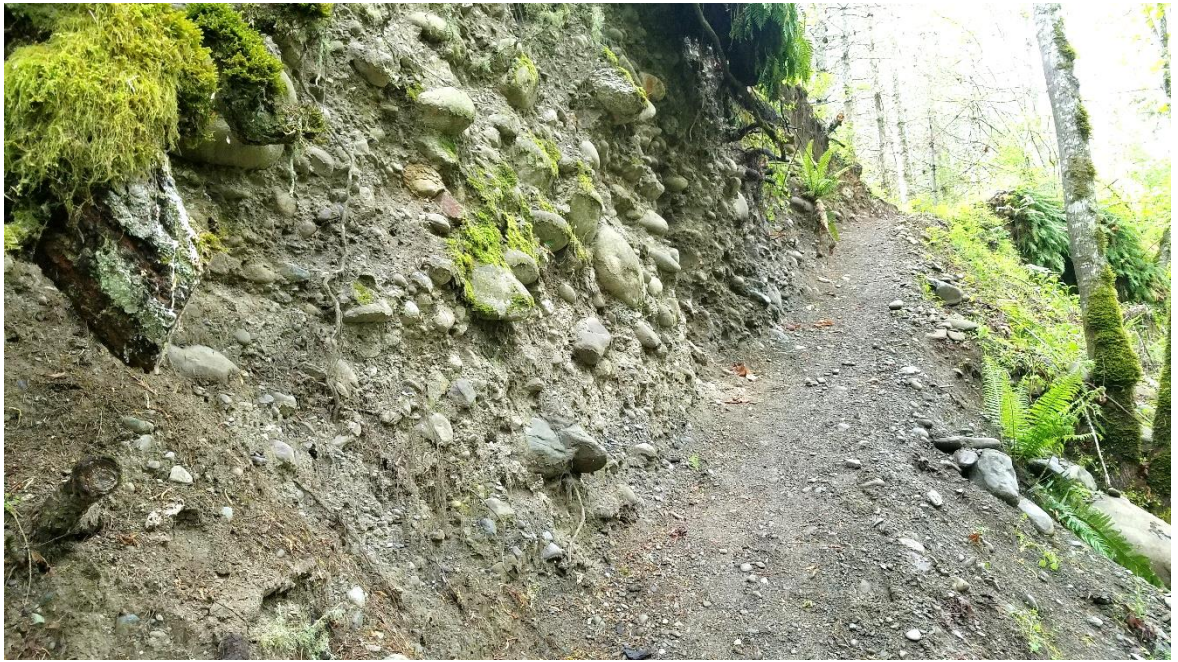
Anchor QEA, performed a preliminary site geotechnical investigation consisting of seven test pits, mainly in the southern portion of the site that was then open (see Technical Memorandum Attachment D-2, referenced above, for pit locations). The preliminary investigation outlined four soil units; a topsoil unit from 0.5 to 1.0 feet, a silty sand unit ranging from 1.0 to 2.0 feet thick, and dense coarse alluvium at depth, except in TP-7, which encountered a silty sand bed below the coarse alluvium. The alluvium is described as consisting mainly of cobbles and boulders, with a matrix consisting of silt, sand and gravel. Finer grained sand and gravel “pockets” or lenses were described in four of the test pits. This is consistent with a bedded alluvial deposit, which can be expected to demonstrate variable gradations across the site (see Plate 3).

**Plate 3.** Outcrop of older alluvium, on the bluff above the present river level, May 13, 2020.

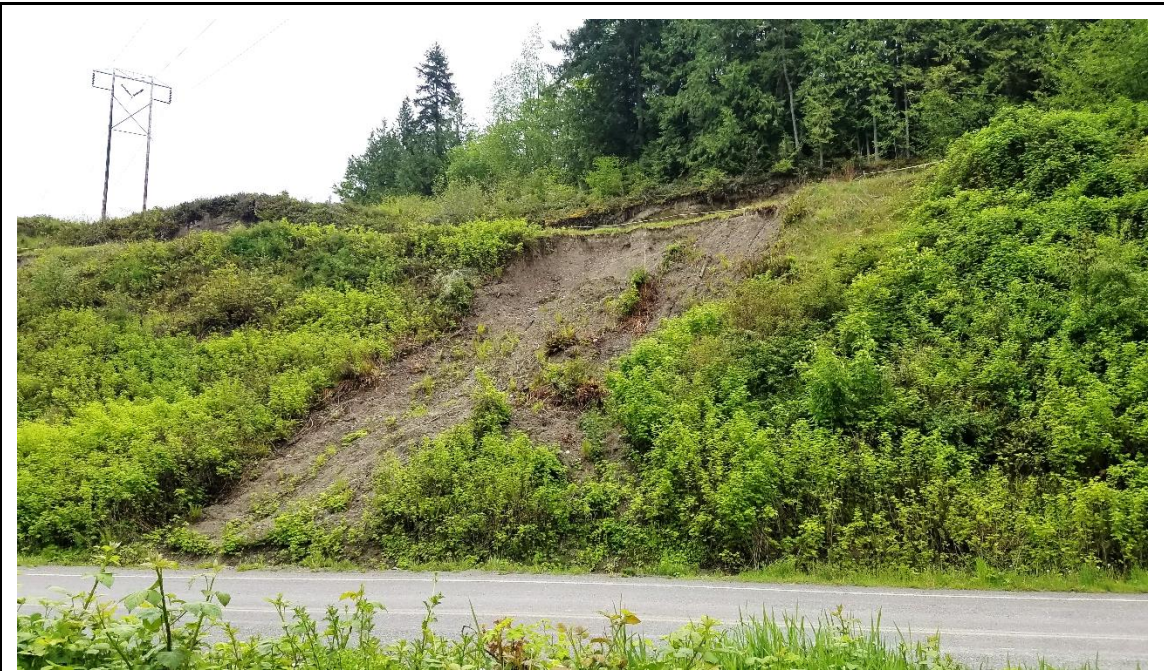
Our site reconnaissance observed one area of sliding, opposite the entry to the main entry to the parking area for the Dungeness Trails, as marked by a warning road sign on River Road. The site has recently experienced a shallow slide (see Plate 4). This small slide consisted of the slumping of surficial colluvium. A smaller slide, that did not extend to the road level, is present off the frame to the left. The entire active zone is roughly 300 feet

**Plate 4.** Shallow landslide above River Road, opposite the parking area for the Dungeness Trails park.

wide, prompting the irrigation district's use of approximately 300 feet of corrugated plastic pipe to cross areas of prior ground movement.

While we observed this small, shallow slide south of the proposed reservoir, we believe that the slide zone will not pose a hazard to the facility. Essentially, active slides in the area are shallow and we did not observe any clear evidence of deep-seated slides. Furthermore, there are no features visible on the Lidar DEM suggestive of any significant instability in the reservoir area.

operation of the facility. In our opinion only an Oso-like, long runout landslide would pose a significant risk to the facility, and such a slide is very unlikely in till soils with shallow bedrock. Even a deep-seated, rotational landslide would not greatly affect the site. If this remains a concern, a slope inclinometer could be installed to confirm the stability of the slope.

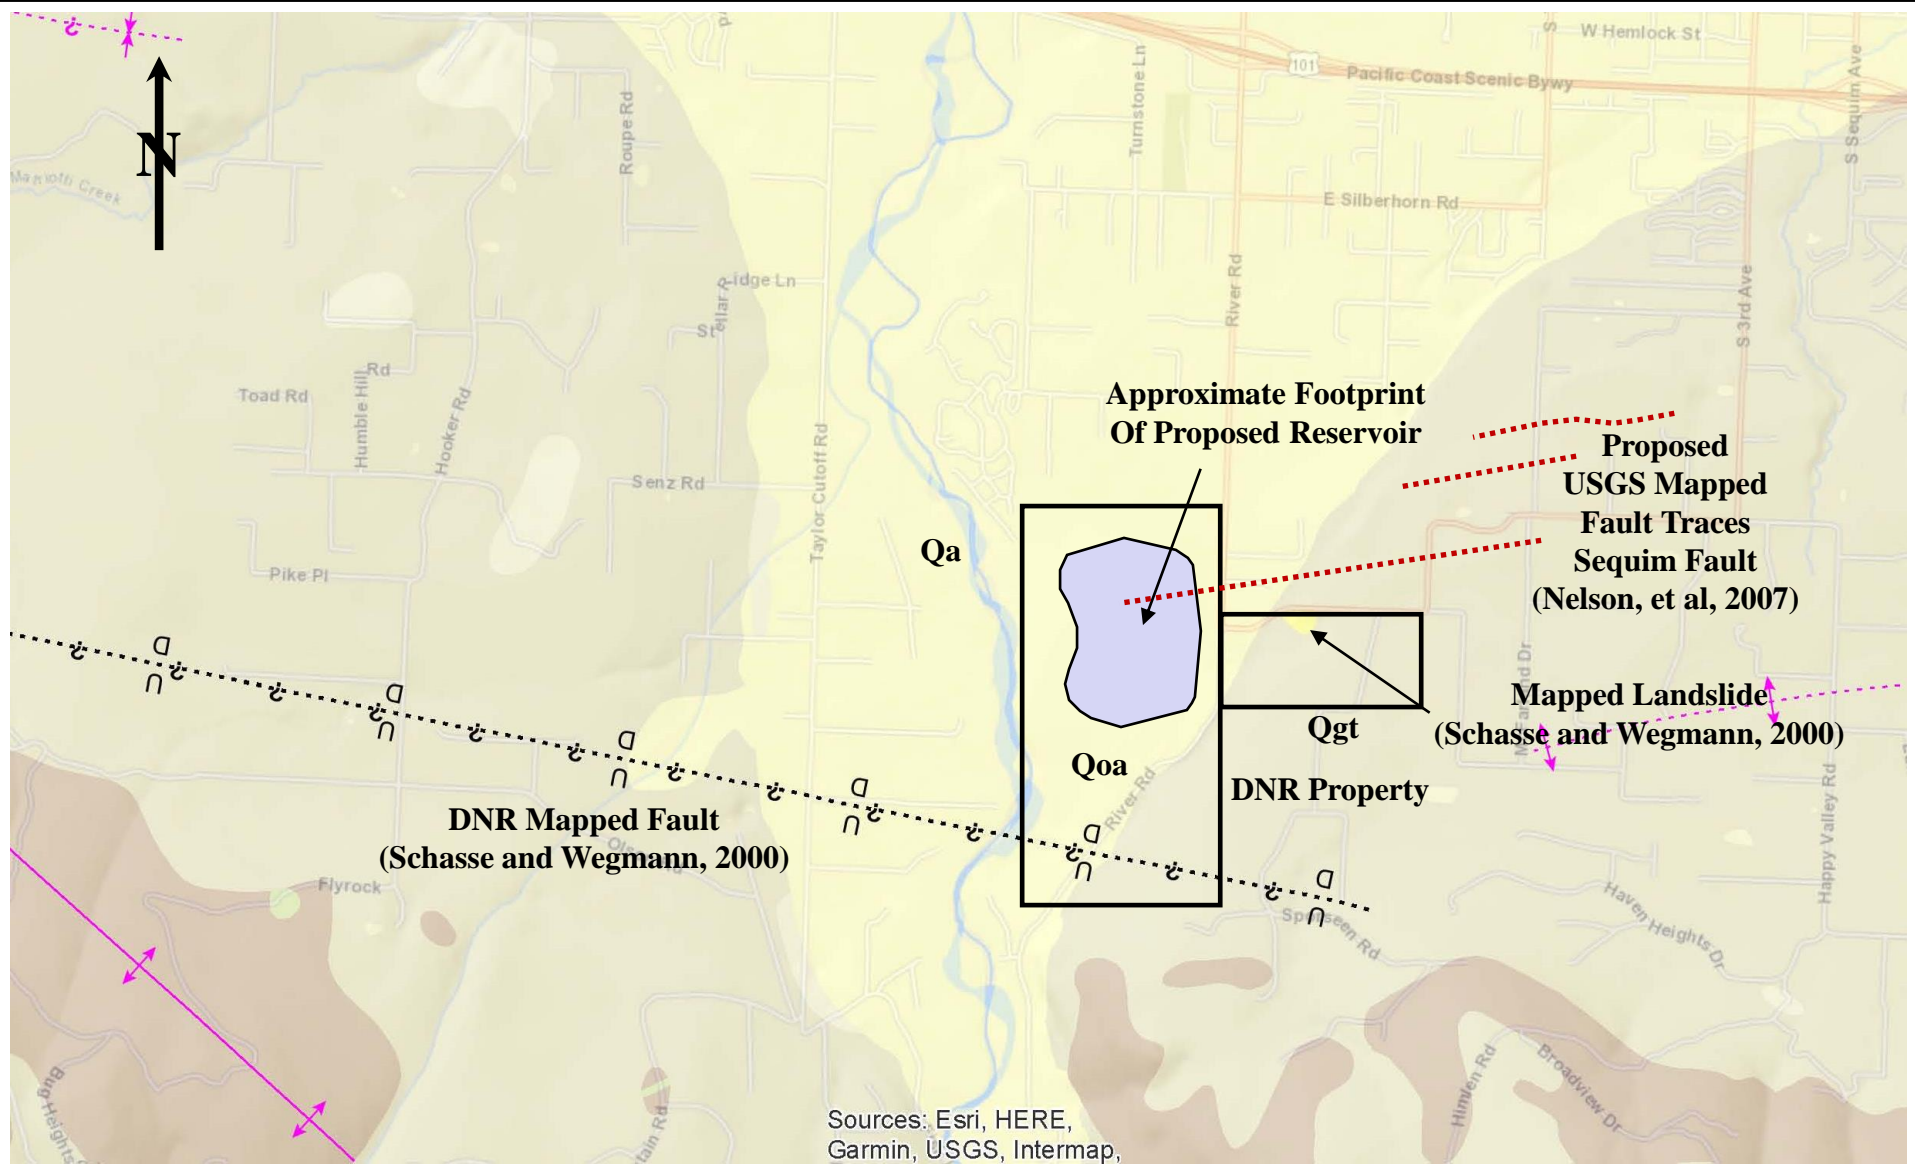
Figure No. 2

Schasse and Wegmann (2000) mapped one small landslide in the area of the proposed project. This landslide was located above Happy Valley Road as it ascended the bluff to the east of the River Road (see Figure 2). To assess the potential for landslide hazard on this site, we reviewed the Lidar imagery for the area (see Figure 3). The area was most recently flown in 2019 (Olympics South Opsw). In the DNR geological review (Shafer, 2019), the Lidar data from 2002, 2008 and 2016 was also reviewed.

Shafer (2019) concluded that there was no evidence for the landslide as mapped by Schasse and Wegmann (2000) and shown on Figures 2 and 3. However, she suggests a deep-seated landslide in the south portion of the property and postulated that the slide was in the area of the fault mapped by Schasse and Wegmann (2000). The feature we believe she identified is marked on Figure 3.

Schasse and Wegmann (2000) mapped a fault running south of the project area, which they infer as a high angle normal fault, dipping and down to the north. This fault motion would

be unusual under the general compressional tectonic regime, and we question the existence of such a fault.
