Title of Report: <u>Cultural Resources Inventory For The Dungeness Streamflow Restoration</u>

# CULTURAL RESOURCES INVENTORY FOR THE DUNGENESS STREAMFLOW RESTORATION OFF-CHANNEL RESERVOIR PROJECT, CLALLAM COUNTY, WASHINGTON

FEBRUARY 11, 2021

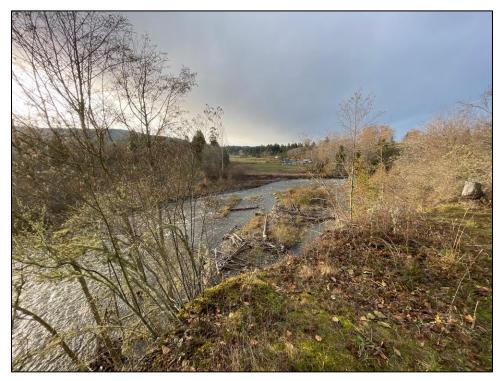
Figure 6.1-3. View of Dungeness River taken from the high terrace that forms the eastern margin of the river floodplain and from the southern edge of BPA ROW, looking northwest.

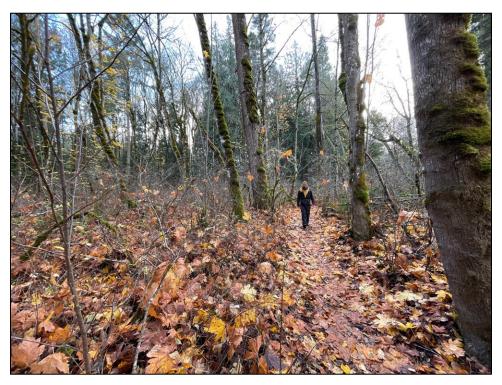
Figure 6.1-4. Survey of Dungeness River floodplain along southwest edge of project area, looking south.

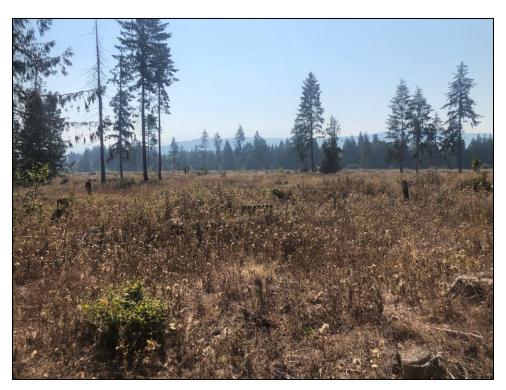
Figure 6.1-5. Northern third of the project area showing the open, flat terrace east of river floodplain and west of River Road (within the proposed reservoir area); looking southwest.

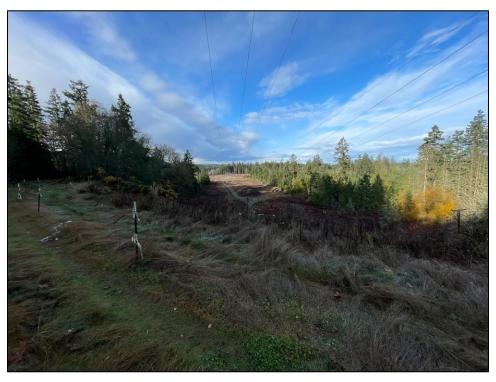
Figure 6.1-6. View of the project area from the Highland Canal and part way up the west-facing slope east of River Road (taken from within the BPA ROW); looking west.

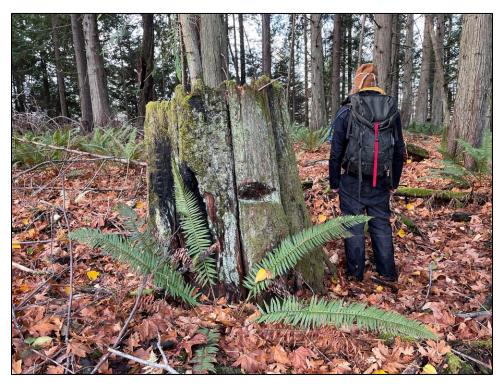
At the time of the survey, the river channel and low floodplain were generally vegetated with a canopy of riparian trees and plants including cottonwood, alder, bigleaf maple, Douglas fir, western red cedar, sword fern, salal, Oregon grape, and various short and tall grassy and weedy species. The water flow within the channel appeared relatively high during the November survey. Multiple remnant cutbanks were observed during the survey along the floodplain, evidence that the main river channel and adjacent floodplain has migrated west. Mineral soil visibility was poor, between 0% and 20%, with duff and leaves covering ground surface within the forested floodplain. The southern third of the floodplain within the project area included several observed springboard-notched cedar stumps, evidence of historical logging activities (Figure 6.1-7).

Figure 6.1-7. A springboard-notched stump is shown, located within the Dungeness River floodplain in the southern third of the project area, looking west.

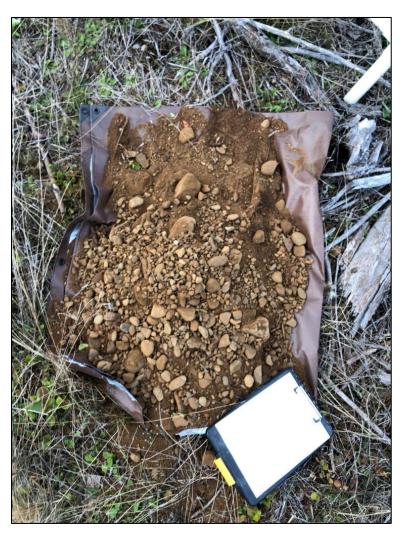
Soils excavated within the proposed reservoir area were consistent with the Carlsborg series gravelly sandy loam mapped for the area (see Chapter 2, Environmental Setting).

Figure 6.1-8. View of screened matrix from SP 15 showing the gravelly sandy loam.

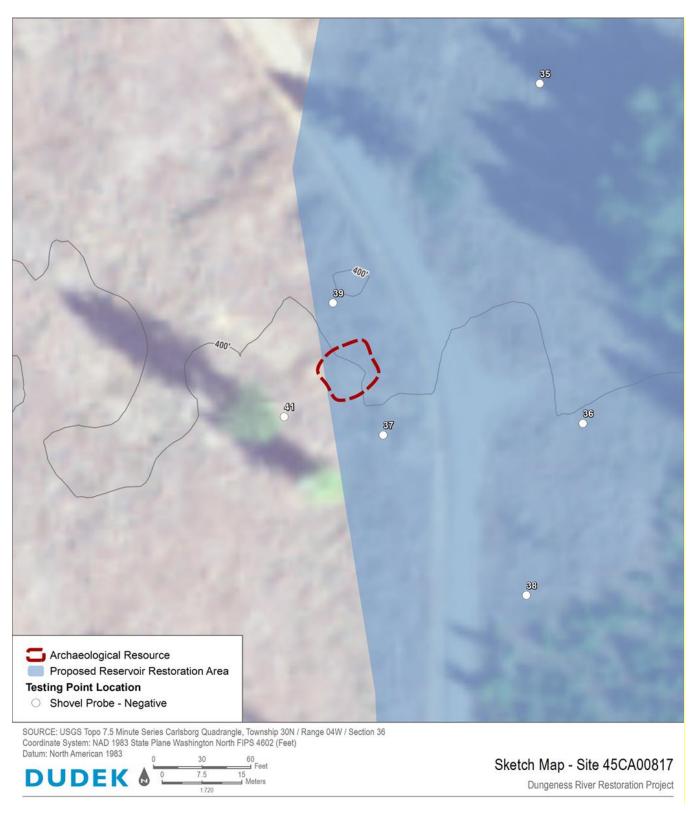
Figure 6.1-9. Sketch map of Site 45CA00817.

The site consists of four amber stubby-style beer bottles, a colorless glass condiment bottle, and six cans identified on the ground. The beer bottles are marked with "NO DEPOSIT NO RETURN" and "NOT TO BE REFILLED" on the body and have stippled heels. "No Deposit/No Return" bottles came into the beer bottle market in the 1940s and are found on stubby-style bottles into the 1970s (Schulz et al. 2019). Two of the bottles have an Owens Illinois makers mark used between 1954 and the present. Two are marked with the Northwestern Glass Company maker's mark and have what are likely date codes of 1962 (Figure 6.1-11) (Bottle Research Group 2019).

Site 45CA00817 is recommended not eligible for listing in the NRHP, due to a failure to convey significance under any of the NRHP criteria and a lack of integrity.

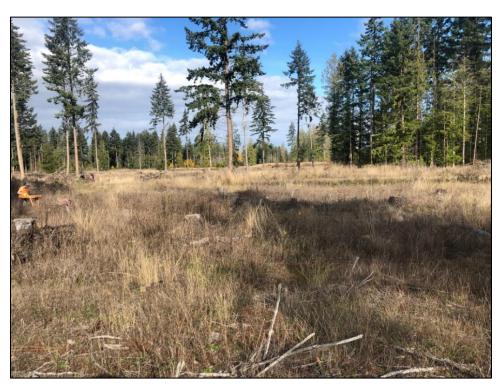
Figure 6.1-10. Overview of 45CA00817 showing SP 39 in progress (left), looking east.

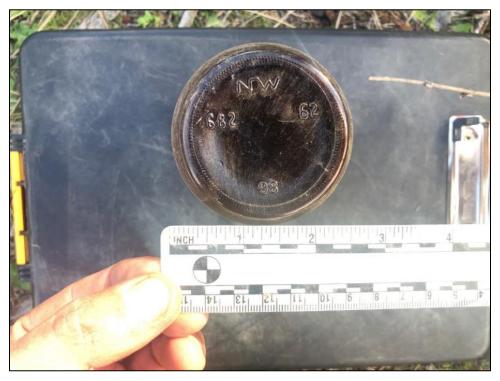
Figure 6.1-11. Detail view of a 1962 stubby-style beer bottle at 45CA00817. The bottle is typical of the beer bottle assemblage.

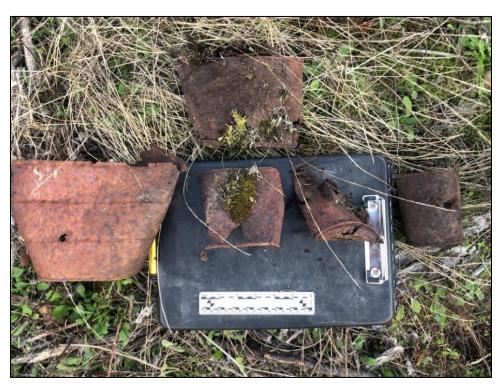
Figure 6.1-12. Detail view of the cans identified at 45CA00817.

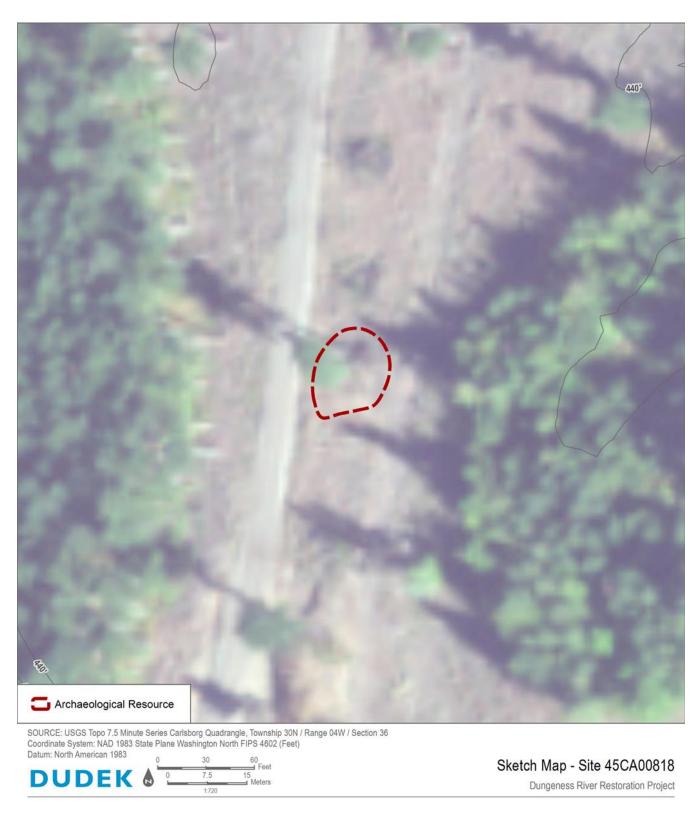
Figure 6.1-13. Sketch map of Site 45CA00818.

Historic-period archaeological Site 45CA00818 consists of approximately 50 pieces of historic-era debris located on a terrace east of the Dungeness River, along an improved gravel road. The site, with its convenient location adjacent to the access road and close to River Road, likely represents a single residential dumping event that occurred in the 1960s. The datable maker's marks are diagnostic for the 1960s and the style of jars, bottles, and other debris is consistent with household refuse of that era. The project area has limited development outside of logging and irrigation infrastructure, and no homes or farms were established in the immediate vicinity of the site. Like 45CA00817, Site 45CA00818 may be associated with the 1960s–1970s development of the residential neighborhood located just east of the project area (USGS 1955, 1979).

Site 45CA00818 is recommended to be not eligible for listing in the NRHP, due to a failure to convey significance under any of the NRHP criteria and a lack of integrity.

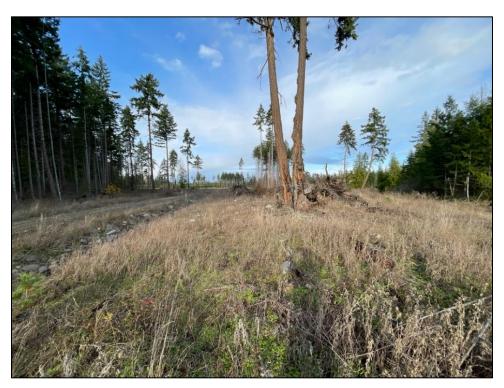
Figure 6.1-14. Overview of Site 45CA00818, looking north.

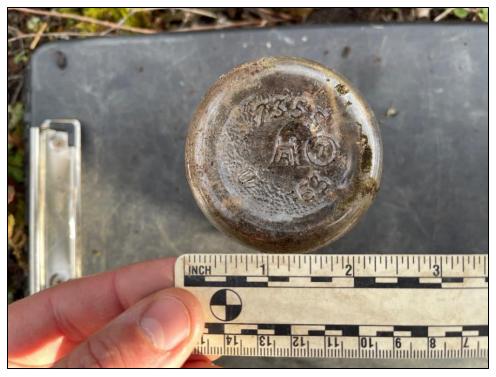
Figure 6.1-15. Detail view a 1963 Hazel-Atlas jar at Site 45CA00818.

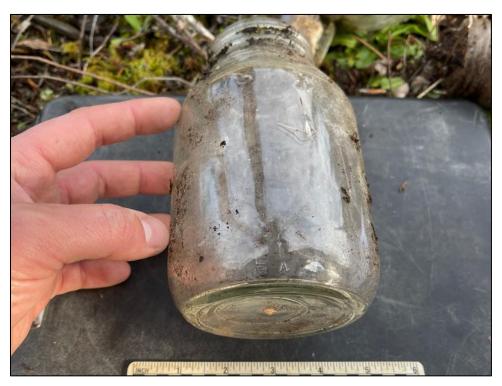
Figure 6.1-16. Detail view of the Glass Container Corporation jar identified at Site 45CA00818, showing the maker's mark on the jar's lower body.

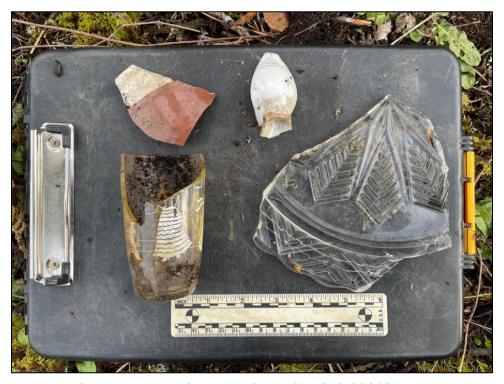
Figure 6.1-17. Detail view of the domestic artifacts identified at Site 45CA00818.

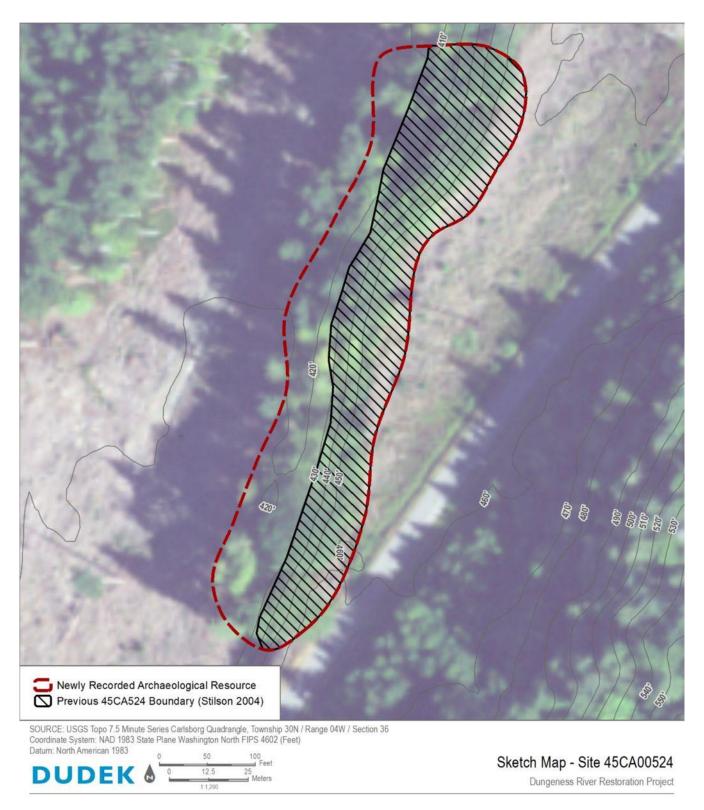
Figure 6.1-18. Sketch map of Site 45CA00524

The site was revisited as part of the current survey and resulted in a slight expansion of the site boundaries west. No new or different artifacts were observed, and the site appeared in the same condition as the original recordation. The site does not appear to be an official dump; it appears more likely that the site represents an expedient, episodic dumping site with easy access from River Road, which is adjacent to the site's southeastern edge.

Site 45CA00524 is recommended to be not eligible for listing in the NRHP, due to a failure to convey significance under any of the NRHP criteria and a lack of integrity.

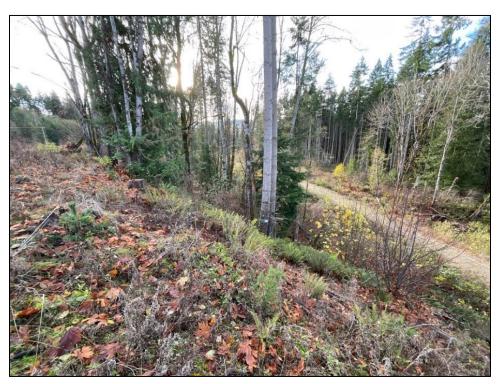
Figure 6.1-19. Overview of 45CA00524 from north edge of site showing the ridgeline (*center*) as well as an improved, graveled access road (*right*), looking southwest.

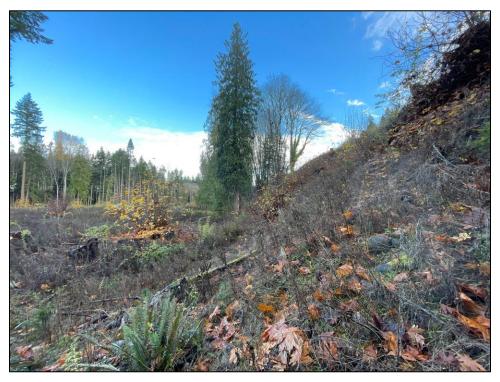
Figure 6.1-20. Overview of 45CA00524 from southern edge of site showing the ridgeline (*right*), atop which sits River Road, looking north.

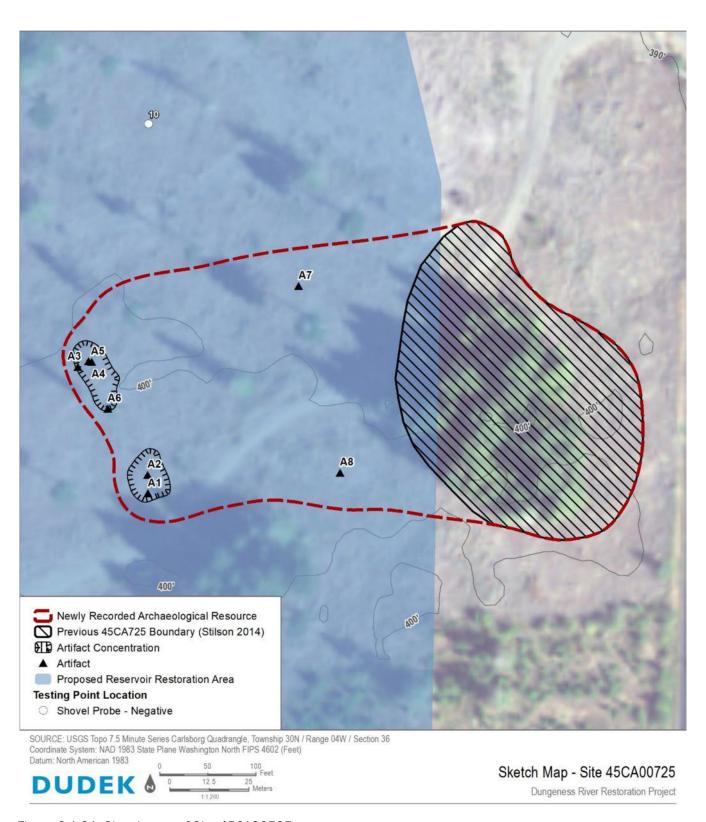
Figure 6.1-21. Sketch map of Site 45CA00725.

Site 45CA00725, known as the Happy Cat Debris Scatter, is a historic-period debris scatter, interpreted as the result of several separate dumping episodes. The site is located approximately 10 meters west of River Road and situated on a relatively flat, open terrace roughly 720 meters east of the Dungeness River (Figure 6.1-21). A stand of trees covers much of the site, but the perimeter of the site and its immediate vicinity have been recently logged. Mineral

Site 45CA00725 is recommended to be not eligible for listing in the NRHP, due to a failure to convey significance under any of the NRHP criteria and a lack of integrity.

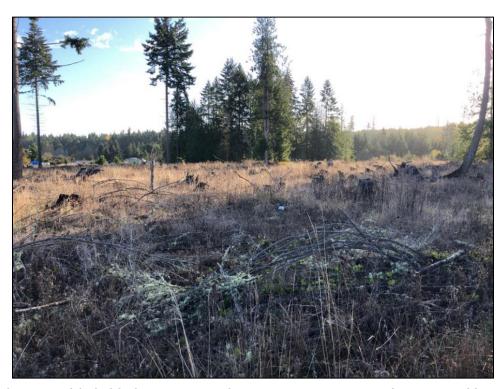
Figure 6.1-22. Overview of 45CA00725, expansion of the site boundary is in the foreground of frame, looking east.

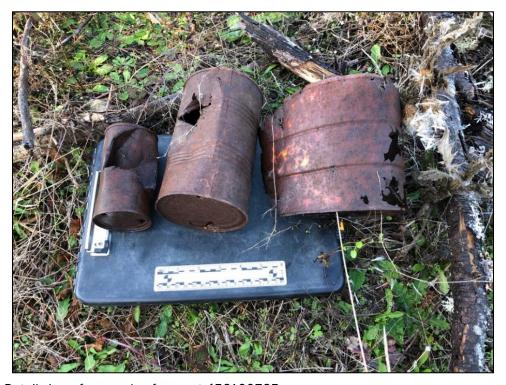
Figure 6.1-23. Detail view of a sample of cans at 45CA00725.

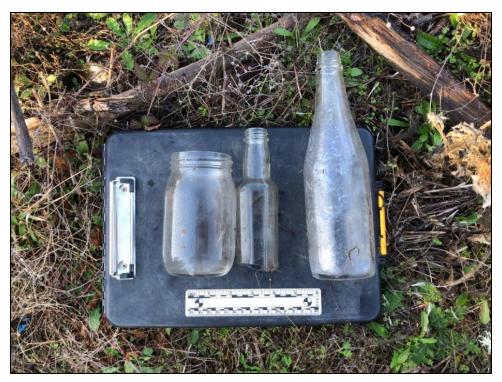
Several bottles were also identified in AC 1 that can be dated to the 1960s (Figure 6.1-24). These include one Northwest Glass Company-manufactured stubby-style amber glass beer bottle (A 2) and two amber beer bottle body fragments marked with "NO DEPOSIT NO RETURN" and "NOT TO BE REFILLED" on the body (Figure 6.1-25). "No Deposit/No Return" bottles came into the beer bottle market in the 1940s and are found on stubby-style bottles into the 1970s (Schulz et al. 2019). A 2 is also embossed with "62" to the right of the maker's mark, which likely refers to 1962 as the year of manufacture. Another stubby-style amber beer bottle was identified in AC 1 with the post-1954 Owens-Illinois maker's mark and "60" to its right. The "60" is likely the date code for 1960, indicating the year of manufacture. Artifact 3, an amber glass bottle embossed on the base with Thatcher Manufacturing Company's maker's mark, was also identified in AC 1. An embossed "62" appears to the right of the maker's mark, suggesting it also was manufactured in 1962 (Bottle Research Group 2019).

Figure 6.1-24. Detail view of a sample of bottles at 45CA00725.

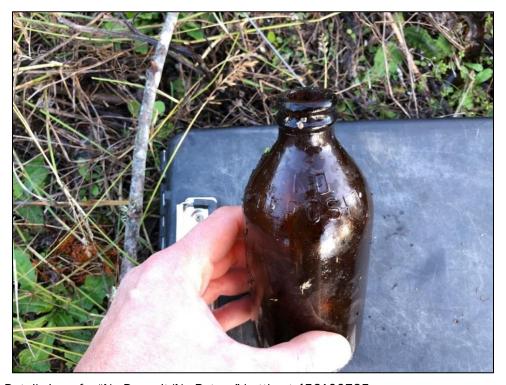
Figure 6.1-25. Detail view of a "No Deposit/No Return" bottle at 45CA00725.

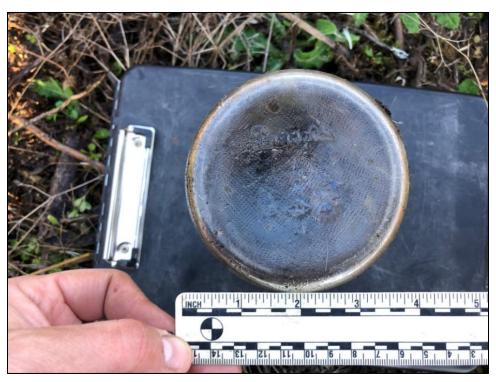
cut opened steel can, metal auto parts, a Hillsboro coffee can, and an Owen-Illinois manufactured colorless glass jug base. The Owens-Illinois jug base carries the maker's mark used between 1929 and 1960 (Bottle Research Group 2019). The "4" embossed on the jug base and the stippling suggest the jug was manufactured in 1944.

Figure 6.1-26. Detail view of an Owens-Illinois Duraglas jar base at 45CA00725.

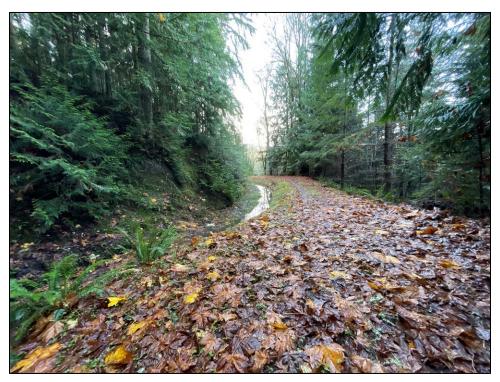
Figure 6.2-2. Highland Canal showing the leaf-covered trail next to it; looking southwest.

The Highland Irrigation District, developed in 1915, was developed after the culturally significant period of initial irrigation development in the Sequim Valley (c. 1895-1897) and is therefore recommended not eligible for the NRHP for its association with these early irrigation efforts (Criterion A). The system is not associated with a significant historical figure (Criterion B) and the system does not represent the work of a master or embody distinctive characteristics of a type, period, or method of construction (Criterion C). The system is unlikely to yield additional information important for the precontact period or history of the region (Criterion D). The Highland Canal has maintained a fair level of historic integrity, such as location, setting, design, feeling, and association, but many of the features have been replaced over time, diminishing the integrity of workmanship and materials. The Highland Canal and laterals HC-1 and HC-2 lack the overall necessary significance to be considered eligible for the NRHP and have somewhat diminished integrity with the replacement of several water management components.

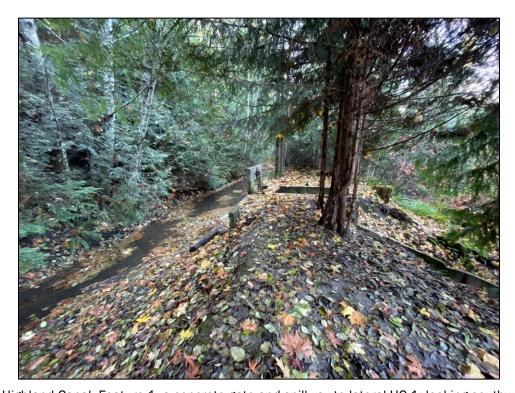
Figure 6.2-3. Highland Canal, Feature 1, a concrete gate and spillway to lateral HC-1; looking southwest.

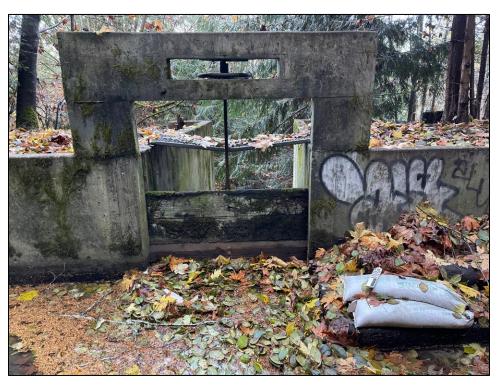
Figure 6.2-4. Highland Canal, Feature 1, showing the metal gate and spillway beyond, looking west. Leaves cover the surface of the water in the canal (*foreground*).

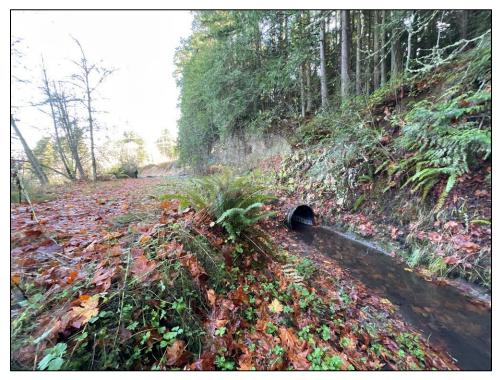
Figure 6.2-5. Highland Canal, Feature 2, showing the southwest end of the plastic culvert pipe channeling the Highland Canal under ground within the BPA transmission line ROW; looking northeast.

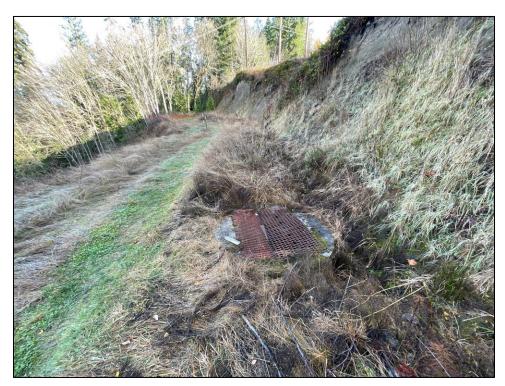
Figure 6.2-6. Highland Canal, Feature 2, showing the concrete enclosure with access to the piped portion of the canal under the BPA transmission line ROW.

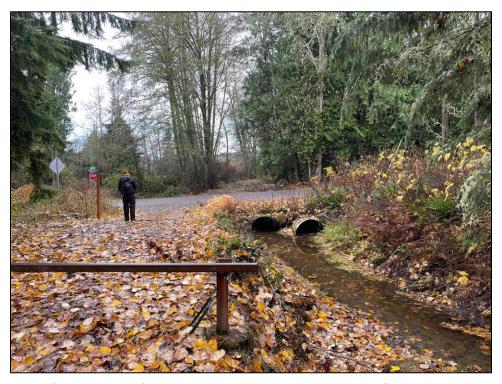
Figure 6.2-7. Highland Canal, Feature 3, showing double culvert pipes beneath Sporseen Road.

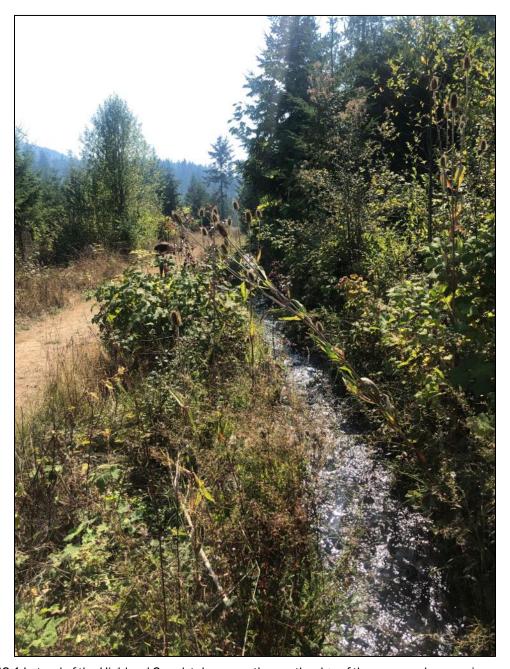
A segment of the Highland Canal Lateral 1 (HC-1), a lateral irrigation ditch of the Highland Canal, is within the project area (Figure 6.2-8). The HC-1 segment measures approximately 1-mile-long and flows west from the Highland Canal beneath River Road through a culvert (Feature 6, see below for details), turns northeast paralleling River Road for 0.25 mile, and then turns north from the road bisecting the midline of parcel 043036210000. Within the project area, HC-1 flows along a relatively flat terrace above and east of the Dungeness River. Vegetation along HC-1 includes both open, recently logged grassy areas and forested areas. HC-1 includes three features (Features 4, 5, and 6) within the project area, described below.

Figure 6.2-8. HC-1 Lateral of the Highland Canal, taken near the south edge of the proposed reservoir area; looking south.

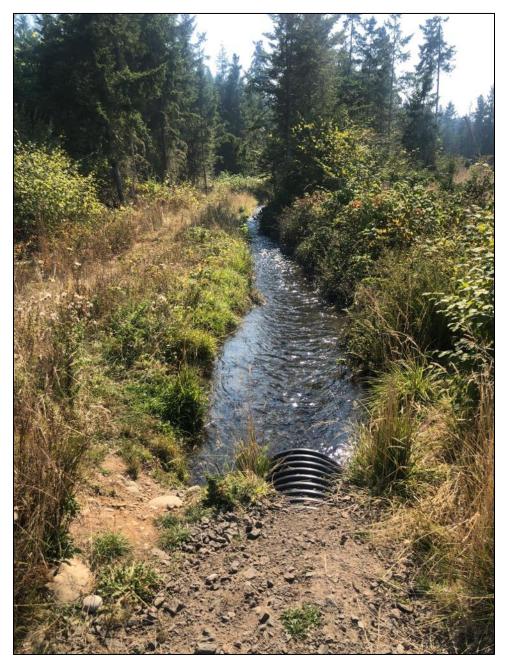
**Feature 4** (F4) is a corrugated plastic culvert pipe and berm for a gravel access road crossing east–west over the lateral ditch within the BPA transmission line ROW (Figure 6.2-9). The culvert pipe measures 2 feet across in diameter and appears to have been recently replaced, either for the recent logging activities within the project area or for BPA's maintenance and access of the transmission line.

Figure 6.2-9. HC-1 Lateral of the Highland Canal, Feature 4, showing plastic culvert under access road within BPA transmission line corridor, looking south.

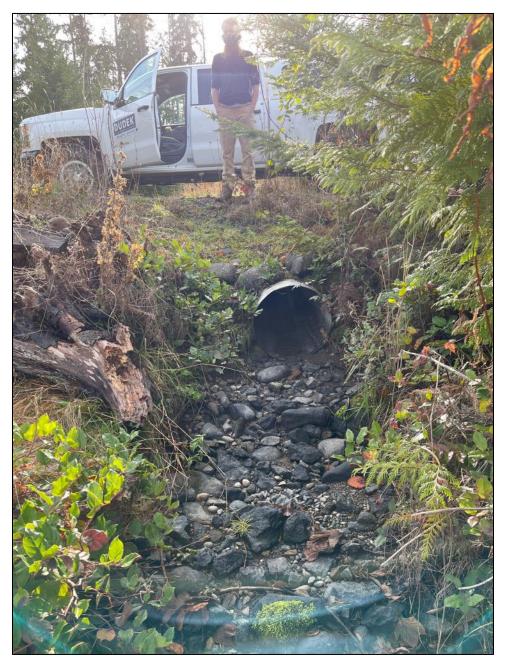
Figure 6.2-10. HC-1 Lateral of the Highland Canal, Feature 5, showing metal culvert under access road within the proposed reservoir area, looking south.

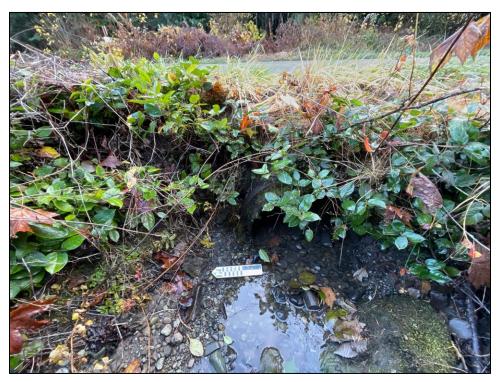
**Feature 6** (F6) is a straight-sided concrete culvert pipe that flows diverted water under River Road from the Highland Canal (Figure 6.2-11). The pipe measures 30 inches in diameter (outer dimensions) by 35 feet long, spanning the width of the road. The floor of the culvert pipe was lined with rounded cobbles.

Figure 6.2-11. HC-1 Lateral of the Highland Canal, Feature 6, the culvert under River Road, looking southeast.

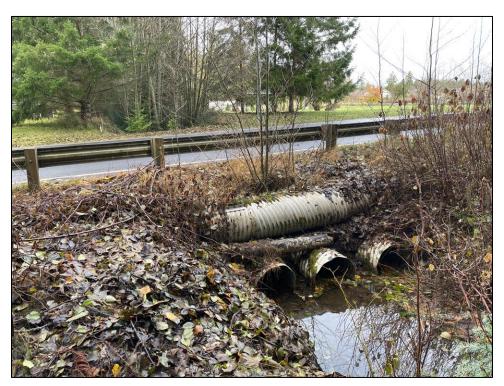
Figure 6.2-12. HC-2 Lateral of the Highland Canal, Feature 7, the culverts under Happy Valley Road, looking northeast.

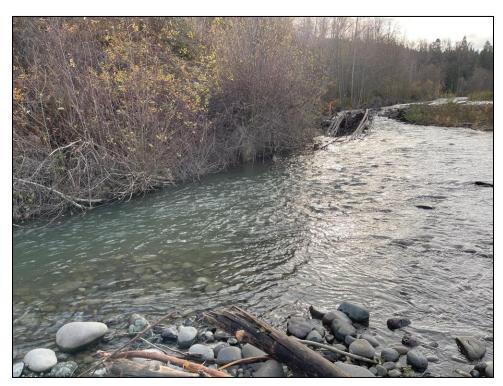
Figure 6.2-14. Independent Intake Canal (*left*, flowing toward bottom left of photo) showing the diversion point at side channel of the Dungeness River (*right*) and concrete escarpment at bank (*background center* under brush) preventing bank erosion, looking southeast.

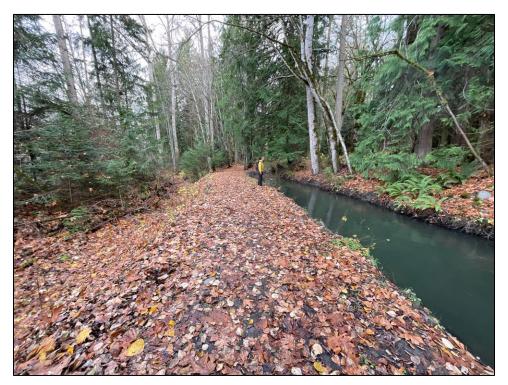
Figure 6.2-15. Independent Intake Canal showing trail on west edge of the canal, looking northeast.

The Independent Intake and Canal, were initially developed in c. 1906, after the culturally significant period of initial irrigation development in the Sequim Valley (c. 1895-1897) and is therefore recommended not eligible for the NRHP for its association with these early irrigation efforts (Criterion A). The system is not associated with a significant historical figure (Criterion B) and the system does not represent the work of a master or embody distinctive characteristics of a type, period, or method of construction (Criterion C). The canals and laterals do not exhibit any distinctive characteristics as described under this criterion. The system is unlikely to yield additional information important for the precontact period or history of the region (Criterion D). The Independent Intake and Canal and abandoned alignment do not appear to have maintained a high level of historic integrity, because it appears to have undergone substantial changes since its construction. The canal appears to have been historically channeled through the abandoned lateral, and later the current alignment was constructed. This change at the canal's diversion point diminishes the overall integrity of the resource. The Independent Intake and Canal lack both integrity and the overall necessary significance to be considered eligible for the NRHP.

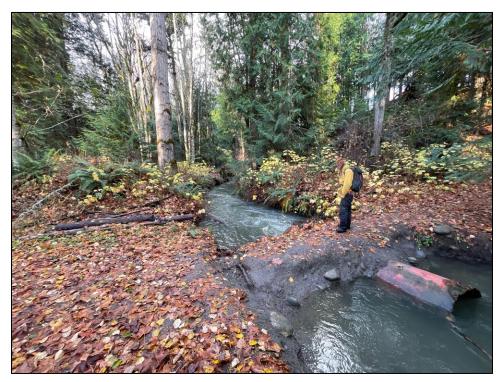
Figure 6.2-16. Independent Intake Canal, Feature 1, showing culvert pipe and berm for pedestrian trail, looking northeast.

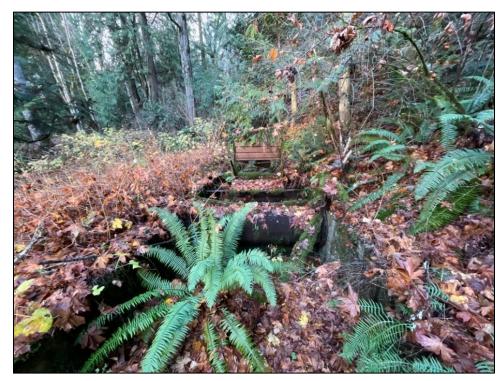
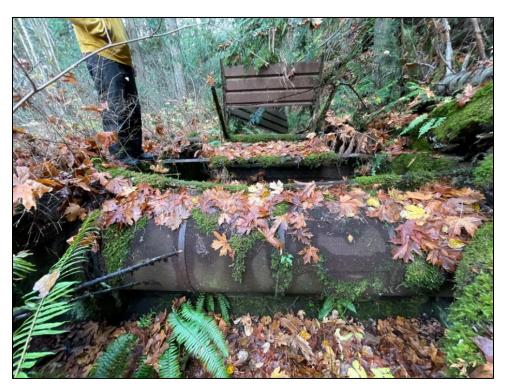
**Feature 2** (F2) appears to be a rotating drum screen mechanism set within a concrete-lined portion of an abandoned ditch (see Feature 3 below) (Figures 6.2-17 and 6.2-18). The concrete-lined portion of the ditch measures 17.5 feet long by 8.5 feet wide by 3 feet high from the bed of the ditch to the ground surface. The concrete walls lining the ditch are 6 inches thick. Set within this structure is a rotating drum and a steel paddle wheel (downstream side of

Figure 6.2-17. Independent Intake Canal, Feature 2, showing the trash screen mechanism and concrete-lined walls of the abandoned ditch, looking northeast.

Figure 6.2-18. Independent Intake Canal, Feature 2, detail view of trash screen and paddle wheel, looking northeast.

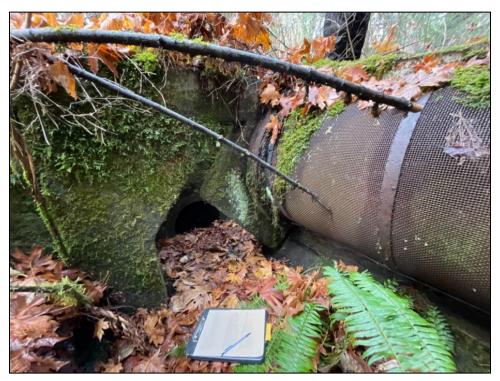
Figure 6.2-19. Independent Intake Canal, Feature 2, showing rotating drum trash screen and culvert outlet, looking northwest.

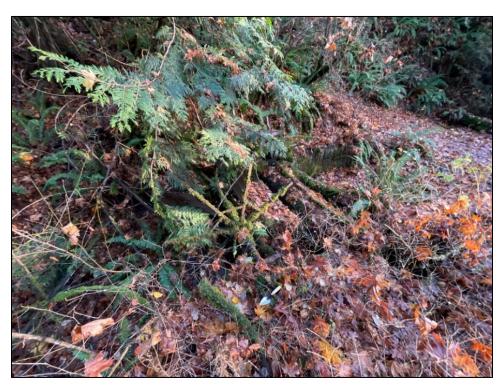
Figure 6.2-20. Independent Intake Canal, Feature 2, showing profile of paddle wheel (center, under tree branches).

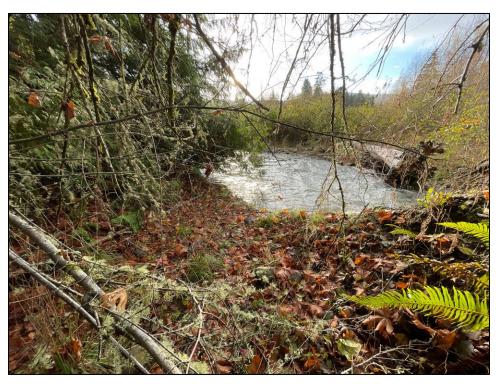
Figure 6.2-21. Independent Intake Canal, Feature 3, showing the southwest terminus of the abandoned ditch at the intake canal (*background*), below the level of the ditch, looking southwest.

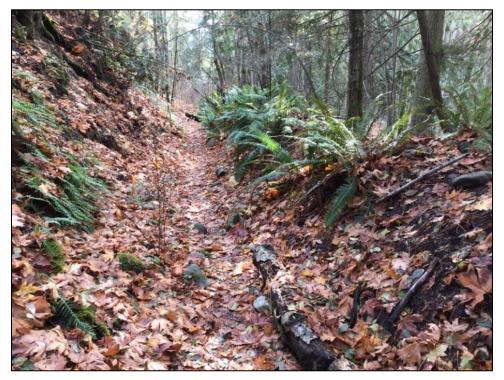
Figure 6.2-22. Independent Intake Canal, Feature 3, abandoned lateral ditch showing overgrown vegetation and the berm (*right*), looking south.

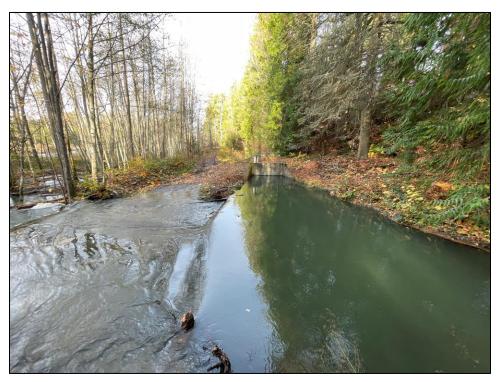
**Feature 4** (F4) is a water-control structure and spillway at the northern terminus of the intake canal (Figure 6.2-23). Water flows north from the intake canal through Feature 4, a concrete-walled structure and steel gate, into the narrower Independent Canal. Just south of the concrete and steel diversion gate, a wide concrete spillway channels the additional flow of water—the water that cannot enter the canal gate—west and back into the Dungeness River.

Figure 6.2-23. Independent Intake Canal, Feature 4, showing spillway (*left*) and diversion gate to the Independent Canal (*background center*), looking north.

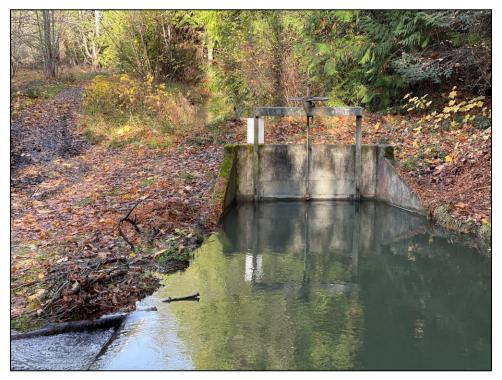
Figure 6.2-24. Independent Canal is shown (*background*) with the diversion gate from the intake canal (Feature 4, *foreground*), looking north.
