January 2022
Proposed Dungeness Reservoir Project

Phase 2 Environmental Site Assessment of the Old Sequim Dump Site

Prepared for
Clallam County
Department of Public Works
223 East 4th Street, Suite 6
Port Angeles, Washington 98362

Prepared by
Anchor QEA, LLC
1119 Pacific Avenue, Suite 1600
Tacoma, Washington 98402

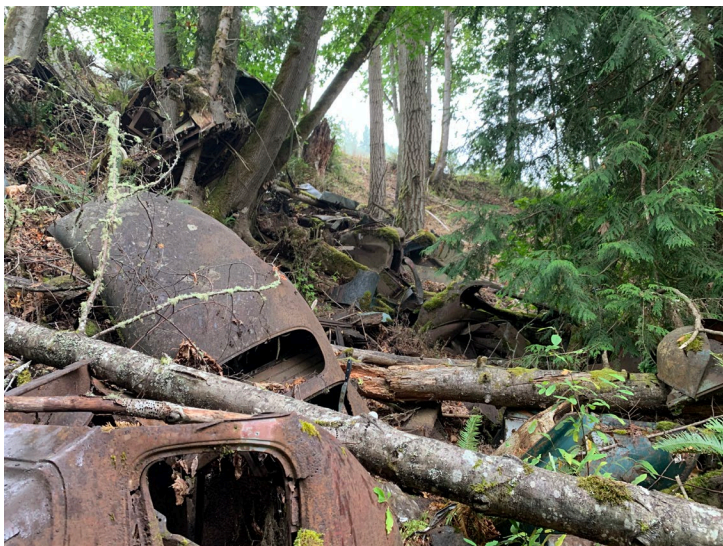
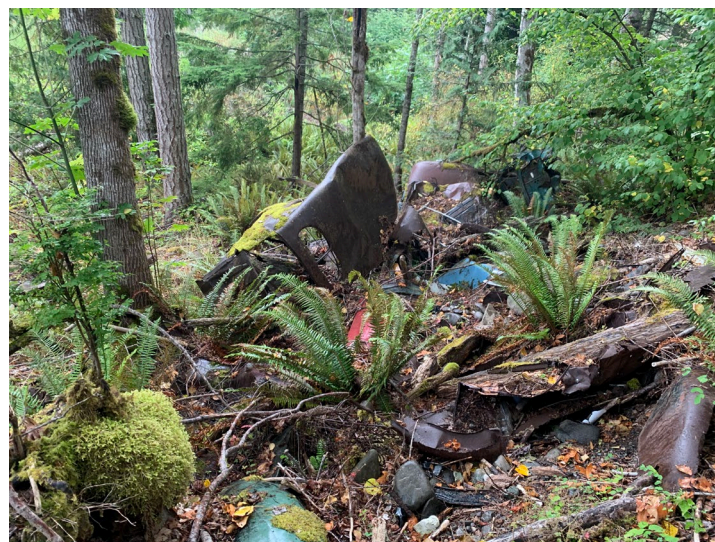
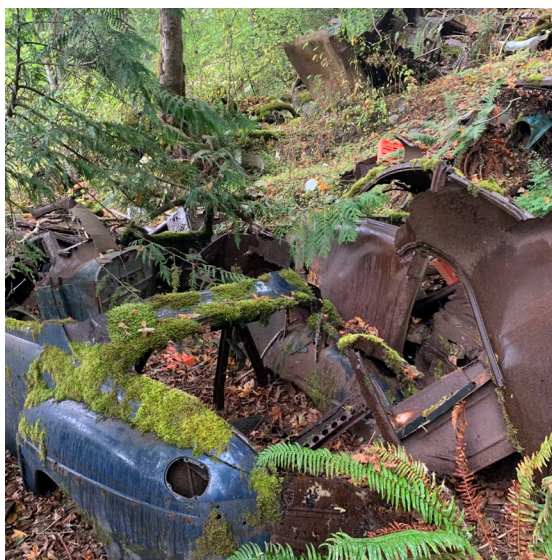
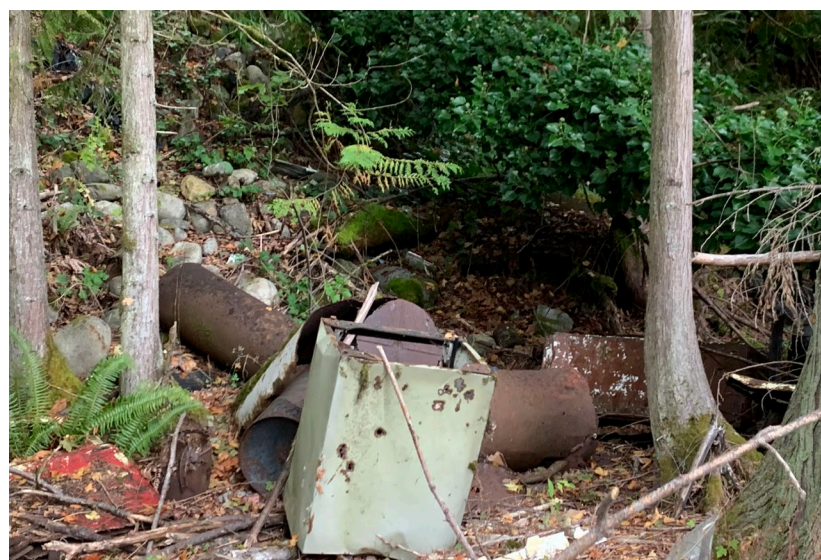
The Dump location is shown in Figure 2. As described in the Phase 1, the Dump had been estimated by DNR staff to cover an area approximately 800 feet long (north-south direction) and 100 feet wide (east-west). The waste materials include automobile bodies and car parts, household appliances, broken glass and other debris and solid wastes.

Within the dump, there were three areas containing more abundant waste materials and a greater proportion of larger objects (e.g., auto bodies, car parts, appliances, tires). These three areas are labeled Area A (south), Area B (middle) and Area C (north) on Figure 3. The waste materials outside of these areas tended to be smaller in size, more scattered, and covered in vegetation. Daily logs documenting the visual reconnaissance and inventory are attached as Appendix A.

Results of testing confirm that some hazardous substances are present in the waste materials and have the potential to release additional contamination to surface soils if the waste materials are not removed. Therefore, Anchor QEA recommends that the waste materials be removed. Given the type and quantity of waste materials present, a thin layer of soil and some trees and other vegetation would need to be removed along with the wastes.
