December 9, 2020  
File No. 20-122

**Re: Geotechnical Engineering Feasibility Report Review  
Dungeness Off-Line Storage Facility  
River Road, Clallam County, Washington**

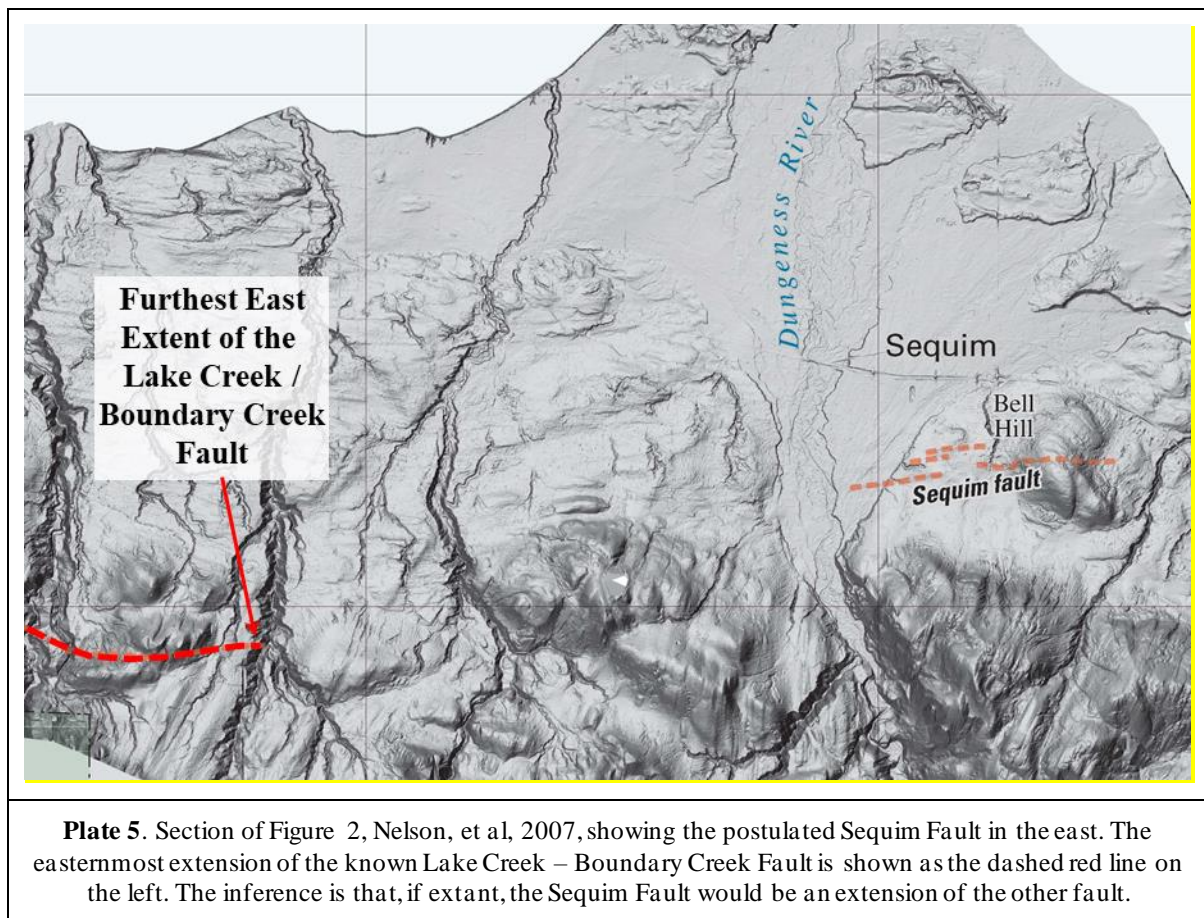
The report of the conclusions was presented in an article published in the Bulletin of the Seismological Society of America (2017) where they conclude that the fault has been active in the Holocene, with several ruptures post 13,000 year BCE, and mainly right lateral strike-slip motion with a vertical component. They postulate a return interval of about 3,500 years, and a maximum potential magnitude of M 7.1 to 7.5. Figure 2 of the 2007 study shows an eastward projection of the fault trend into the Sequim area, that they label as the Sequim Fault (see Plate 5, and Figures 2 and 3). However, they make no explanation of the basis of this projection, nor is the Sequim Fault described elsewhere in the 2007 or the 2017 papers. To the best of our knowledge, this is the only source for the existence of the Sequim Fault. From discussions with Brian Sherrod of the U.S.G.S., we understand that if evidence was strong for this lineament, the Nelson team would likely have conducted a trench investigation of it.

Schasse and Wegmann (2000) mapped a fault running south of the project area, which they infer as a high angle normal fault, dipping and down to the north. This fault motion would

be unusual under the general compressional tectonic regime, and we question the existence of such a fault.
